AVIATION INVESTIGATION REPORT

A03A0022

LOSS OF CONTROL AND COLLISION WITH TERRAIN

CESSNA 210N, N104WF

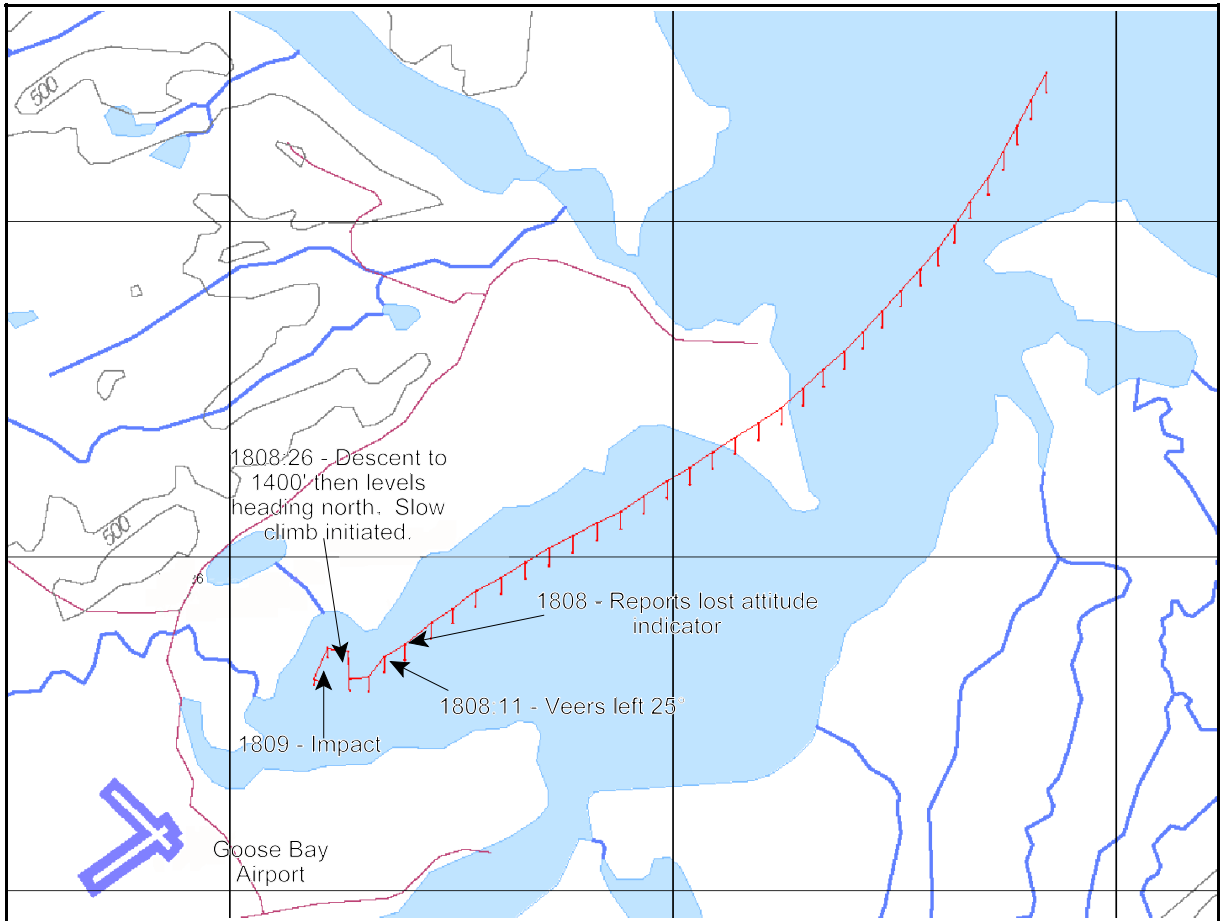
Appendix A - Final Flight Path

At 1800, while 23 nautical miles (nm) from the Goose Bay airport, the aircraft had descended to 2000 feet and was cleared for a straight-in precision approach radar (PAR) to Runway 26. Air traffic control radar data showed that the aircraft proceeded inbound at 2000 to 2100 feet, with occasional small corrections to maintain the on-course track (See Appendix A - Final Flight Path). At 1808, just inside 6 nm from Goose Bay, the pilot radioed that the attitude indicator had failed. The PAR controller immediately reverted to "No Compass" approach procedures, advising the pilot to disregard the compass.

Shortly after the pilot's transmission, the aircraft veered left, descended rapidly to 1400 feet, then levelled on a northerly heading. The PAR controller then discontinued the approach and attempted to aid the pilot by advising of necessary corrections to the flight path. The aircraft stayed on a northerly heading for approximately 20 seconds climbing gradually to 1600 feet; it then entered a spiral dive to the left. The PAR controller initiated a search immediately upon losing radar and radio contact with the aircraft. The aircraft wreckage was found by ground
